# **Shawlands Conservation Area**

# **Shopfront Survey**

**FINAL DRAFT**

Lesley Kerr, Historic Buildings Consultant May 2015

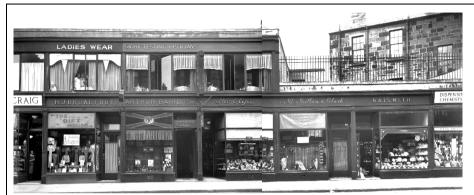
16-34 Kilmarnock Rd. 1939 (Glasgow City Archive-Ref. C6337&8) & 2015 showing dominance of patchwork signage

- 16-34 Kilmarnock Rd.-Poorest appearance.
  Control signage & promote co-ordinated design. Attached to Listed building at Cross
- 45-57 Kilmarnock Rd.— Reveal & repair details of original elegant shops, restore proportions & co-ordinated signage.
- 63-75 Kilmarnock Rd.-Opportunity to create a new unified design.
