Summary Report

285 Wallacewell Road
Glasgow
G21 3RP

Beatroute Music Group

Report Date: 30th September 2010

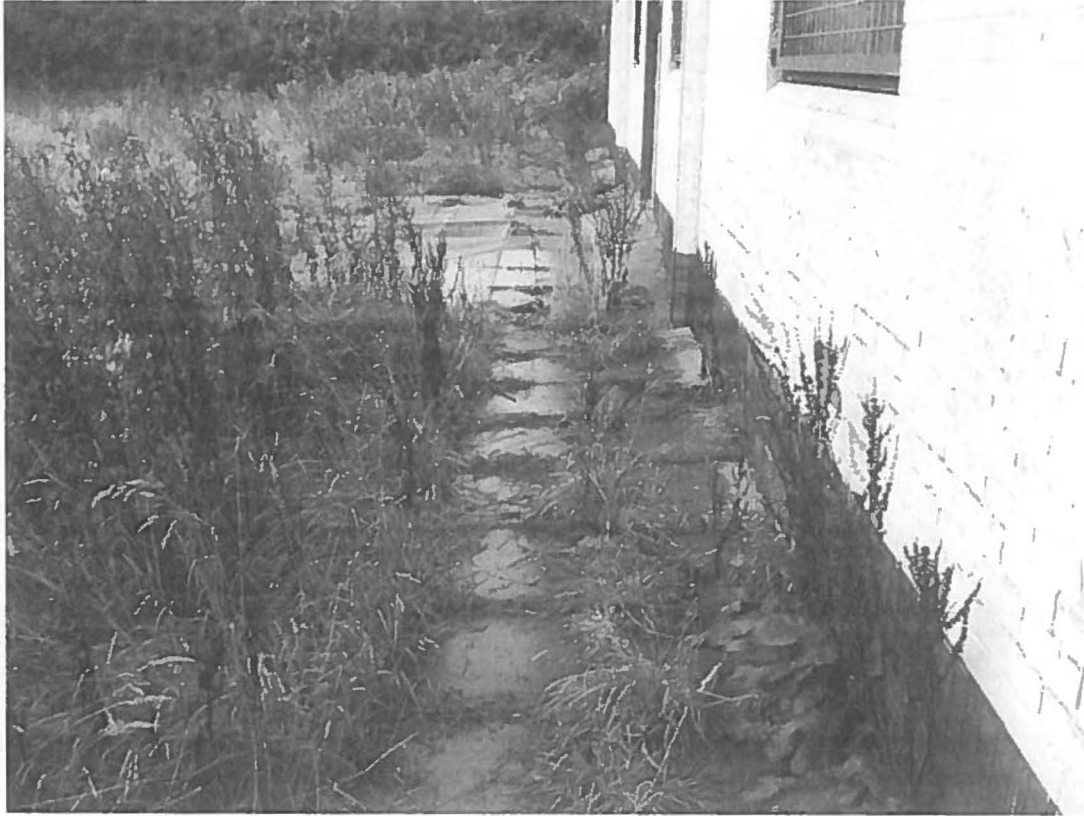
4. PAVEMENT TO WEST ELEVATION

- 3.31 The pavement to the west elevation is ramped steeply at its centre to accommodate the external fire exit door. The gradient of the slabs is greater than permitted by current Building Regulations which also require a level exit plinth with an unobstructed length of 1.50m before the exit route is ramped to adjacent pavements. The paving slabs have also been positioned so that they sit proud of the exit threshold, creating a trip hazard. We would recommend that the exit paving be reformed.

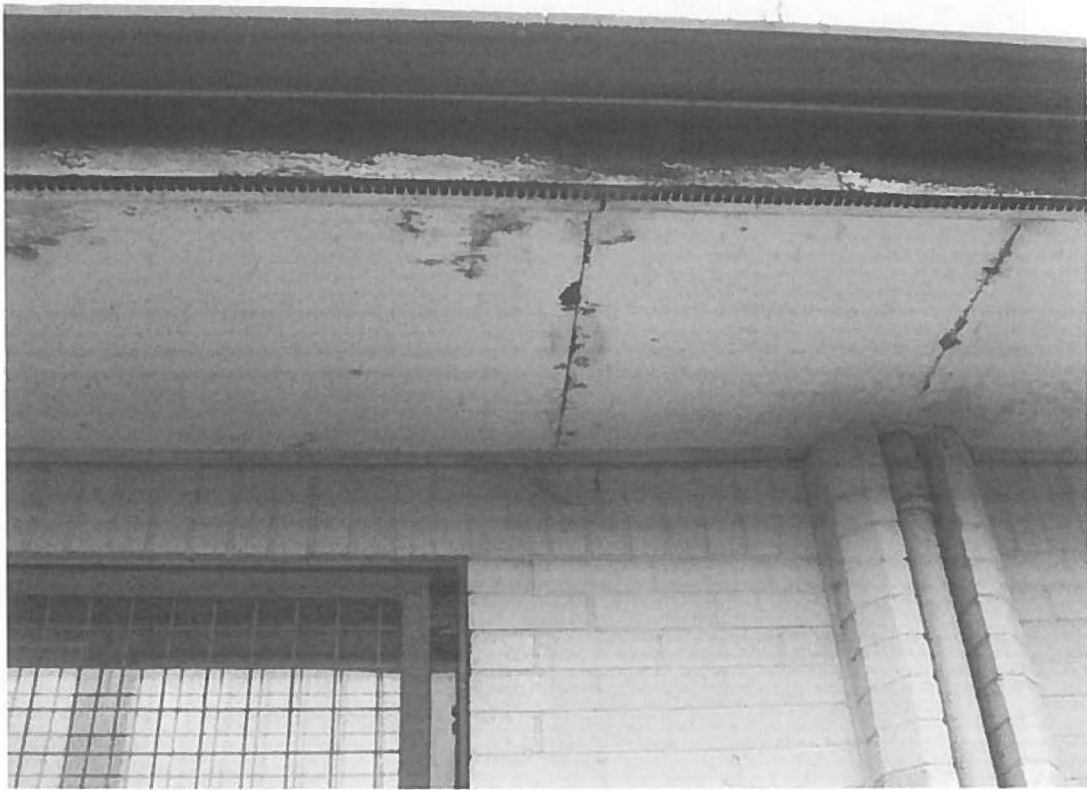
- 3.11 The gutters are connected to the downpipes via short lengths of shallow pitched downpipes concealed within the eaves soffit. Extensive water penetration was noted through the soffit to the west side of the roof, suggesting that the concealed length of downpipe in this location is broken or disjointed. The soffit requires opening up and the downpipe repaired as necessary.

7. WATER DAMAGE TO SOFFIT BOARDS

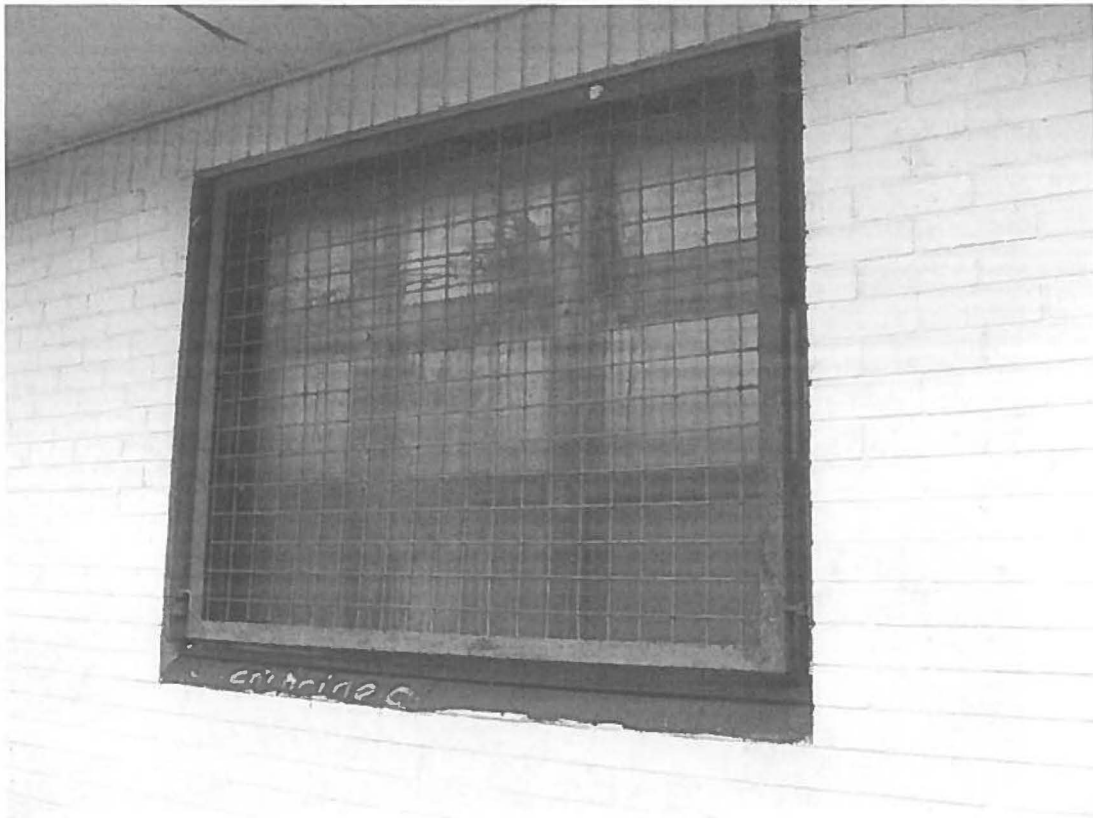
8. TYPICAL WINDOW

- 3.23 Where checked, opening casements were found to be operational. A number of windows are obscured internally by paper or similar.
- 3.24 Externally the windows and framework are heavily soiled, particularly towards the front of the property. The paint finish is becoming worn and is heavily flaking to the steel mesh protection. Perimeter mastic seals, where visible, were found to be cracked and debonding.

- 2.19 Exterior windows and doors are in fair to poor decorative order generally, with the windows towards the front end of the building particularly soiled. Perimeter mastic seals to the perimeter windows are also locally damaged, and the protective grilles are in poor decorative order with an extensively flaking paint finish. Perimeter seals, where visible, are cracked and debonding. Doors have been defaced by graffiti. All are in need of cleaning down and redecoration, with the replacement of damaged perimeter seals.

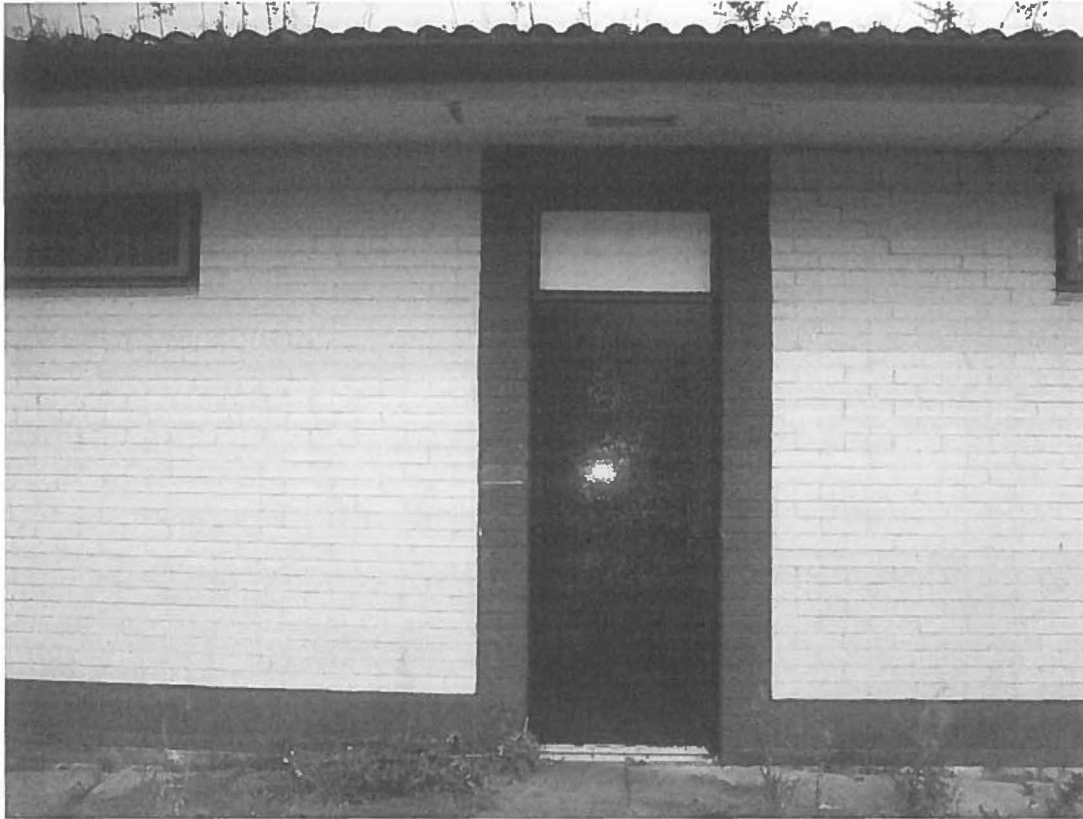
- 3.19 Mortar pointing is substantially sound, although locally eroded at low level, particularly to the south elevation. Step cracking is present through the brickwork at high level, located either side of the fire exit door to the east elevation. The cracking appears to be the result of additional weight added to the roof structure within the Games Hall, where scaffolding spanning the roof structure has been used to support 6 No. punch bags. The weight of these punch bags is considerable, and consideration should be given to their removal to avoid further damage. The brickwork externally will require repointing.

- 3.42 The roof structure within the Games Hall has been augmented with the addition of scaffolding to support 6 No. punch bags. The weight from the scaffolding and the punch bags will be significant, and this appears to have contributed to the stepped cracking noted either side of the fire exit door to the east elevation. The punch bags should be removed to avoid further damage.

9. CRACKING TO BRICKWORK TO EAST ELEVATION OF GAMES HALL

- 2.17 Stepped cracking is situated to the high level brickwork either side of the central fire exit door to the east elevation. This cracking appears to have arisen as a result of additional loading added to the roof structure from scaffolding and 6 No. punch bags within the Games Hall. The brickwork will require repointing prior to redecoration and we would recommend that consideration be given to removing the scaffolding and punch bags supported from the roof structure to avoid further damage.

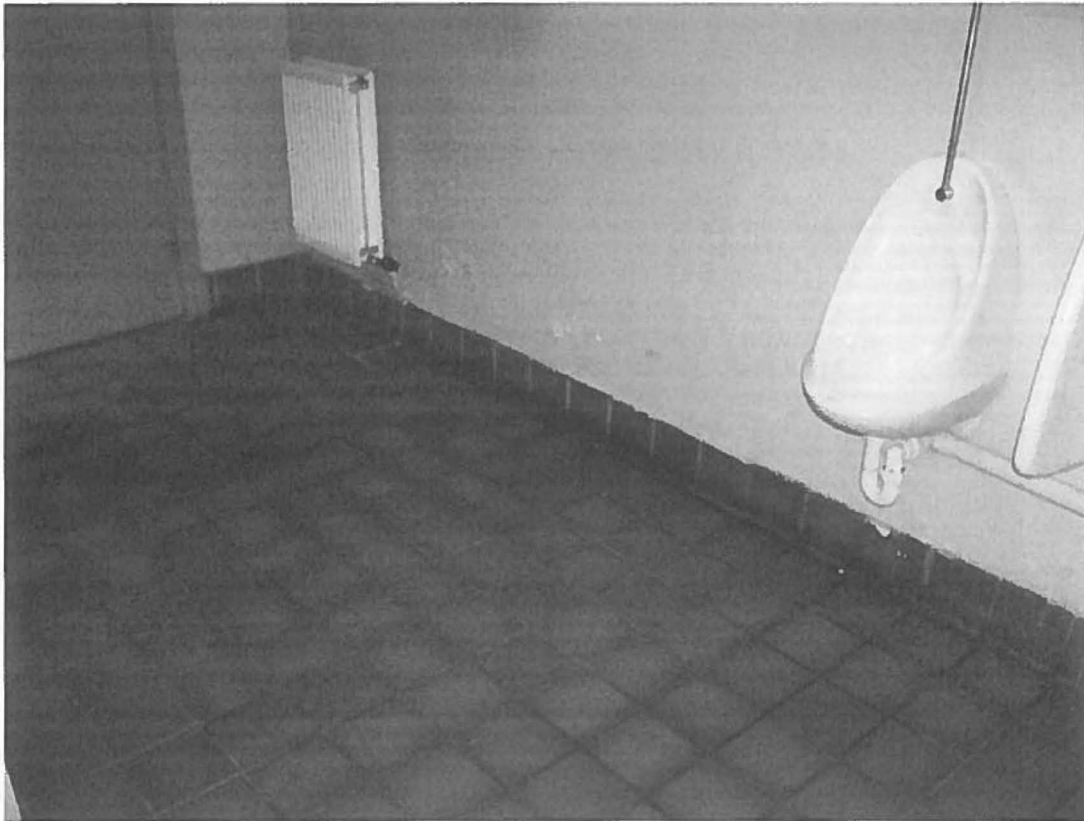
- 3.44 Localised dampness was noted at low level to the walls within the toilet accommodation, particularly the female toilet, in the northeast corner of the property and to the north wall of the Games Hall. This has resulted in localised deterioration of the plaster and paint finish. The source of the moisture is not clear and it may be the result of a localised breach in a damp proof membrane. If it is of concern, localised repairs would be recommended which, if necessary, may require the insertion of a chemical damp proof course prior to the repair of the plaster and decorative finishes.

13. DAMP AFFECTED PLASTER TO MALE TOILET

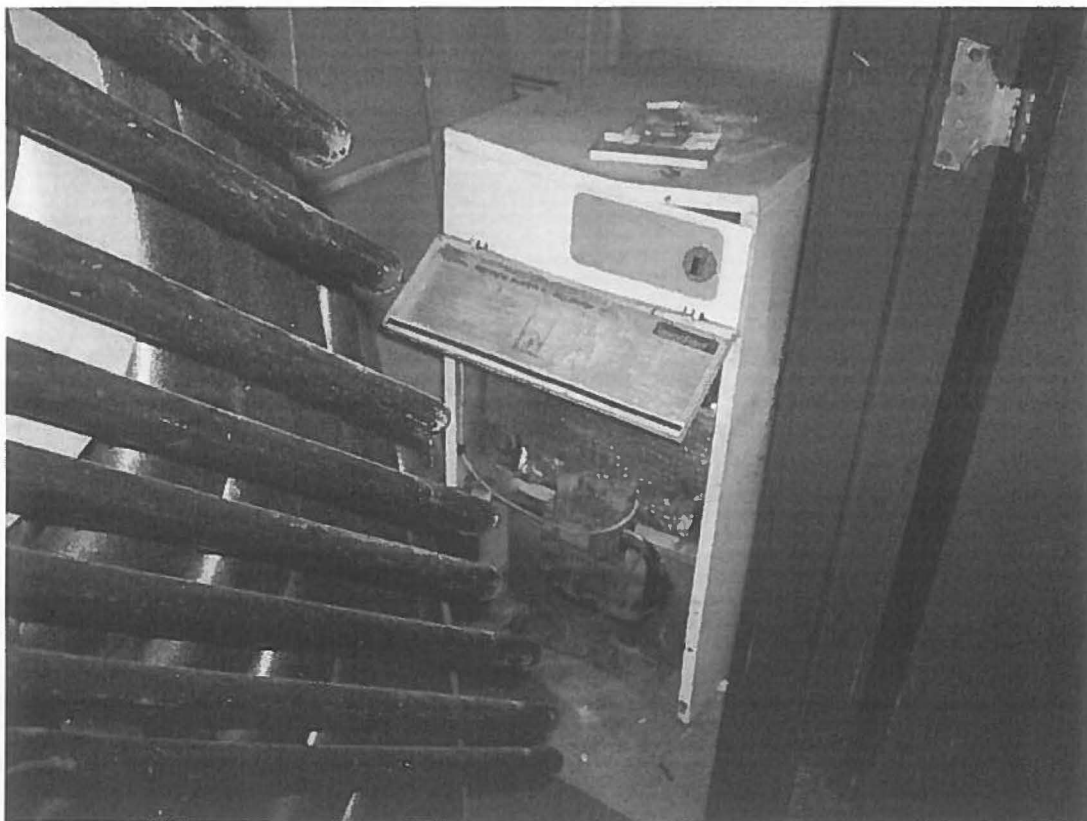
14. BOILER

- 4.07 The boiler is an Ideal Standard "Mexico Super II" and appears relatively old. At the time of our inspection, a smell of burning was noted, and following discussion with the Tenant we understand that the boiler had been switched on for the first time in a period of approximately 6 months earlier that morning. During the course of our inspection the boiler was inspected and the gas supply switched off by representatives of City Property LLP. The boiler appears to be approaching the end of its effective life and will require inspection and certification by a Corgi registered engineer or equal and approved. It is possible that the boiler will require replacement, if not now, then within the next few years.

- 2.25 The gas fired boiler installation was producing a burning smell at the time of our inspection. The boiler is old and we would strongly recommend that it is inspected, repaired and certified as safe by a competent qualified, Corgi registered, or equivalent engineer prior to further use.

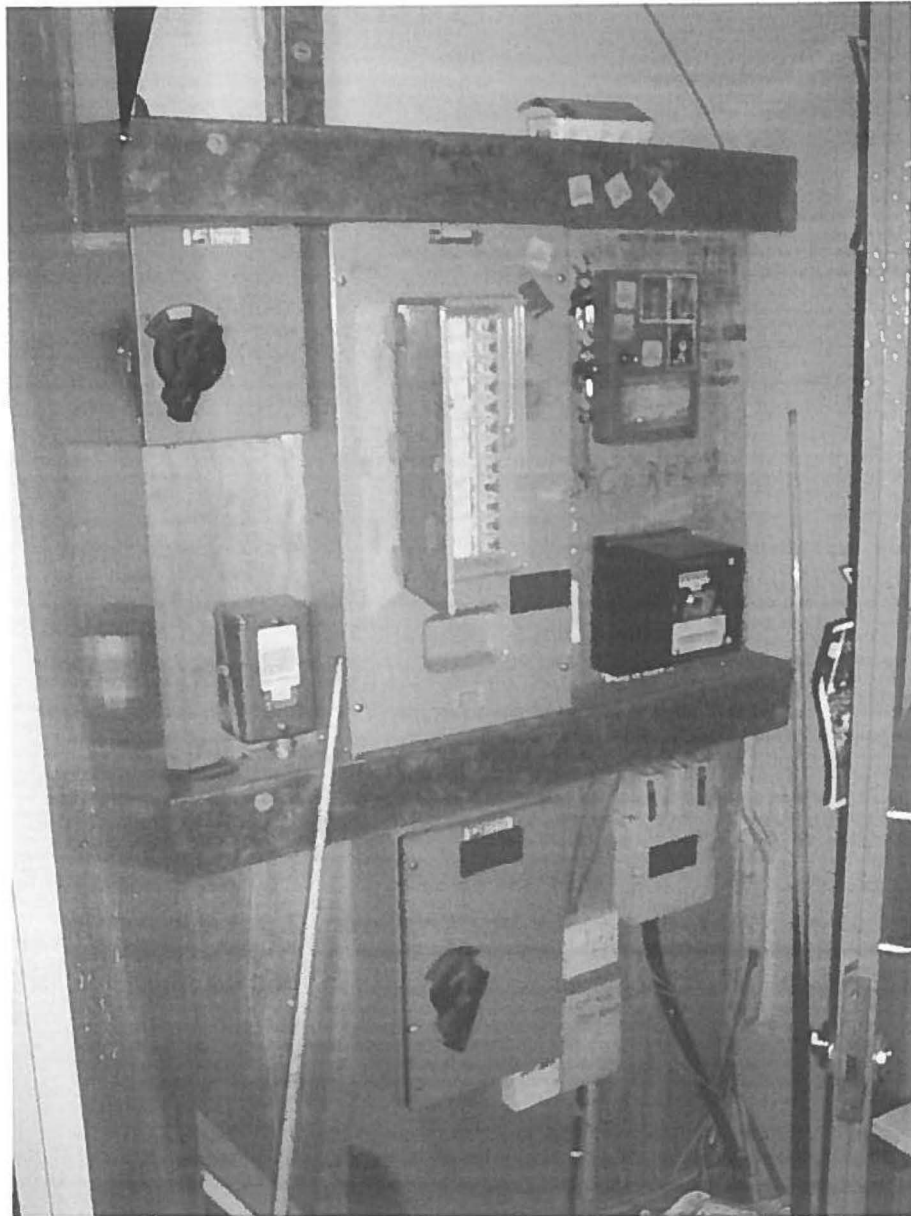
15. ELECTRICAL SWITCH GEAR AND METER

- 4.02 The electrical installation appears reasonably modern and in fair condition, although should be inspected and tested by a competent qualified electrician. Minor gaps were noted between isolated socket plates within the "Caretaker's" office and to the north wall of the Games Hall, and these should be sealed to prevent the insertion of foreign objects. A switch plate serving the lighting within the cleaner's cupboard is broken and inoperable, and a recessed spotlight is missing from the soffit of the entrance lobby to the male toilet.
