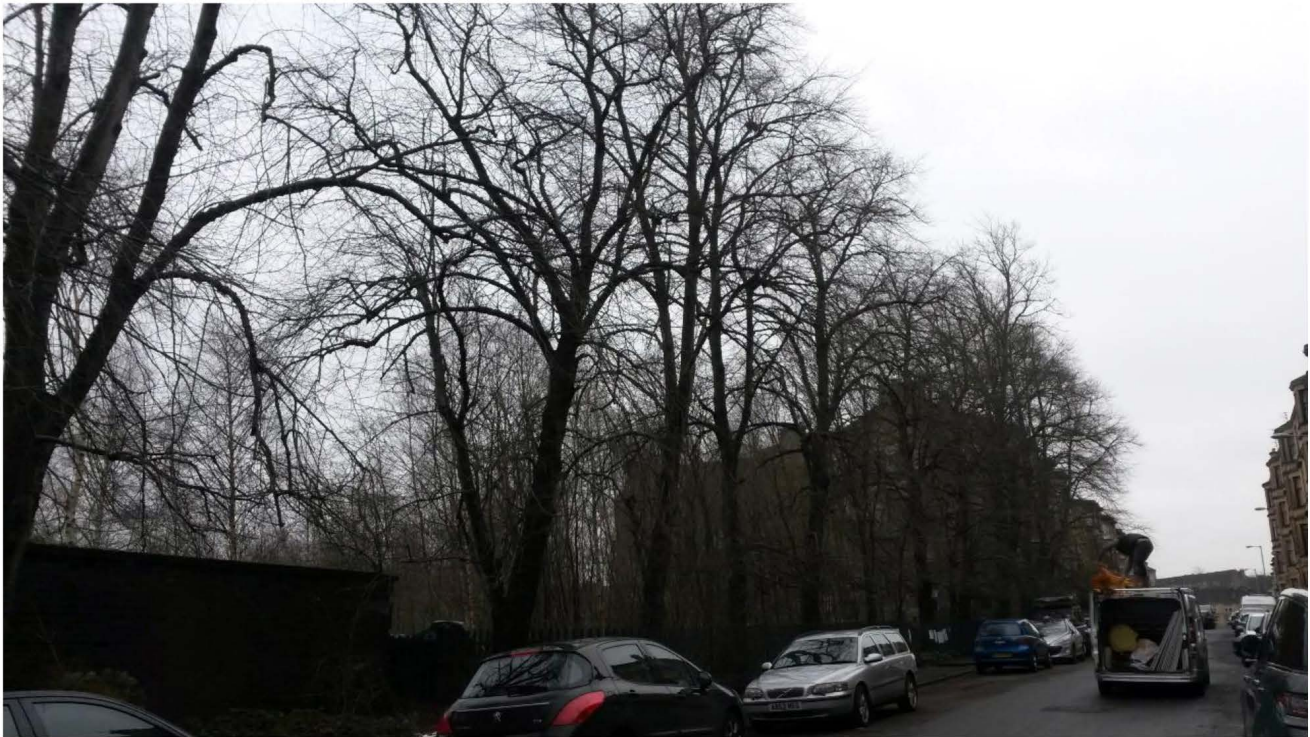
**Photograph 1:** *Lime trees (Tilia x europaea) on the Clouston Street boundary protected by Tree Preservation Order*

The established right of way passes through the root zone of tree 3999 and this has caused serious compaction within the root zone. Gentle cultivation with hand tools is recommended to aerate the soil followed by mulching and the addition of a thick layer of wood chip over the wearing surface to reduce further damage. In the long term it would be appropriate to consider installing a 'no-dig' ground protection system for the first 10m of footpath from the entrance to beyond the trees to minimise further damage (see, for example, <http://www.groundtrax.com/> or <http://www.terram.com/> ).

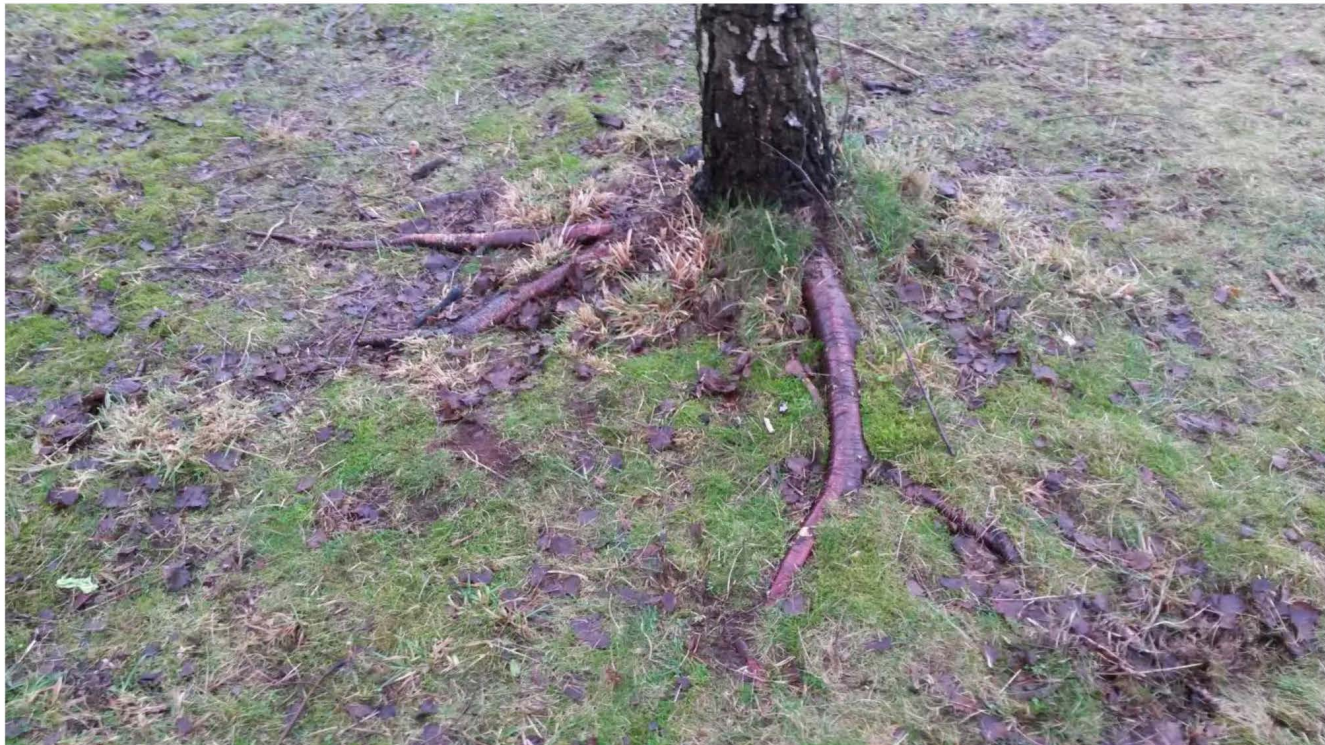
In all of the areas of woodland described below the woodland has developed on blaes and the compacted nature of the rooting medium has resulted in poor rooting conditions and exposed roots as a result. The extent of compaction and poor rooting means that the trees on the site will be more vulnerable to windthrow as they gain height and mature. There is an urgent need throughout the site to introduce management techniques to reduce compaction and improve aeration and nutrient status of the rooting medium by soil cultivation (with hand tools to minimise damage to tree roots) and frequent mulching (with well-rotted bulky organic matter) to improve nutrient levels and encourage the development of soil

**Photograph 2:** *Compaction and poor rooting medium has resulted in poor rooting throughout the site leaving the trees vulnerable to windthrow.*

structure. All leaf litter should be left on site (within the woodland areas) or composted and returned to the root zones of the trees.
