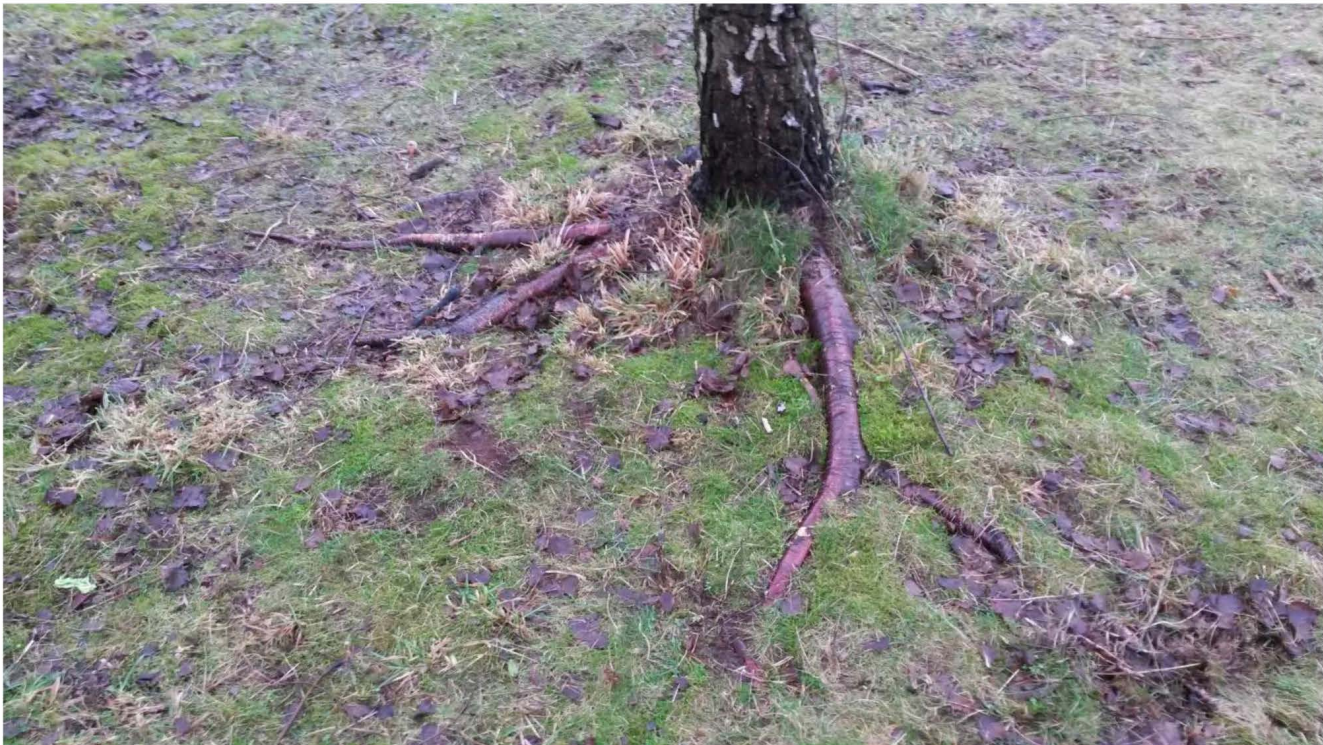
In all of the areas of woodland described below the woodland has developed on blaes and the compacted nature of the rooting medium has resulted in poor rooting conditions and exposed roots as a result. The extent of compaction and poor rooting means that the trees on the site will be more vulnerable to windthrow as they gain height and mature. There is an urgent need throughout the site to introduce management techniques to reduce compaction and improve aeration and nutrient status of the rooting medium by soil cultivation (with hand tools to minimise damage to tree roots) and frequent mulching (with well-rotted bulky organic matter) to improve nutrient levels and encourage the development of soil

Photograph 2: *Compaction and poor rooting medium has resulted in poor rooting throughout the site leaving the trees vulnerable to windthrow.*

structure. All leaf litter should be left on site (within the woodland areas) or composted and returned to the root zones of the trees.
